UNITED STATES COAST GUARD

**INVESTIGATION INTO THE CIRCUMSTANCES
SURROUNDING THE EXPLOSION AND FIRE
ABOARD THE TANKSHIP**

OMI CHARGER

**ON OCTOBER 9, 1993, AT BOLIVER ROADS
INNER ANCHORAGE NEAR GALVESTON,
TEXAS, WITH INJURIES AND MULTIPLE LOSS
OF LIFE**

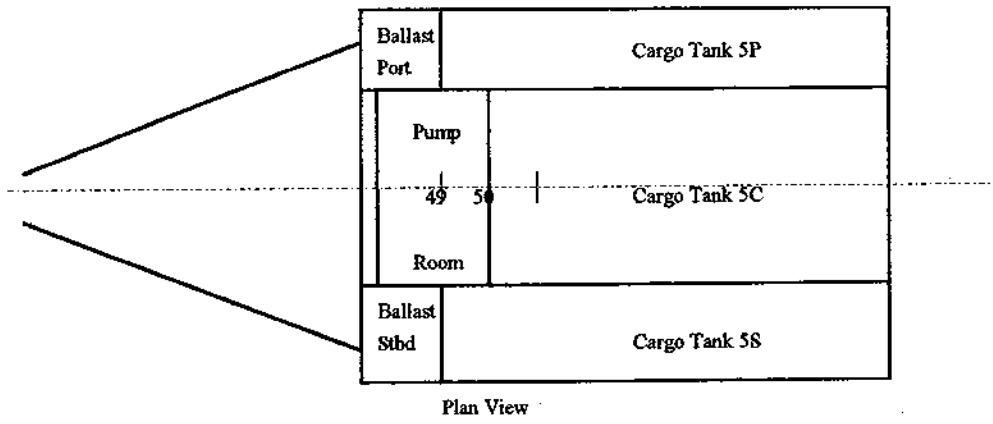
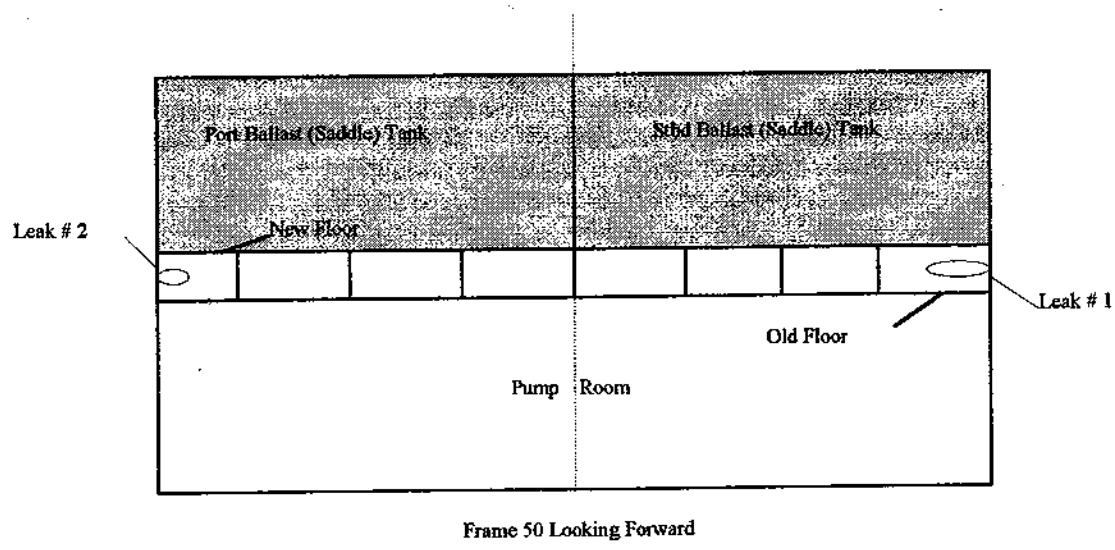
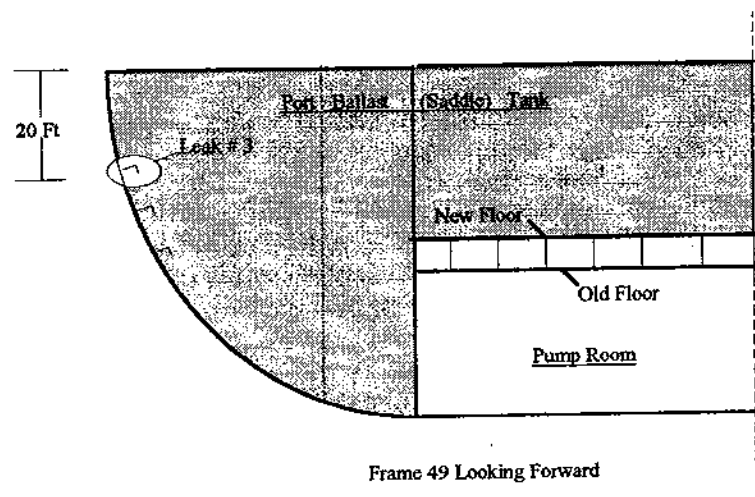
Figure 2, Location of Leaks (not to scale)

18. Three different blends of gasoline were loaded. At about 0330 on October 1st, the third mate, Tara Ziegler, making rounds in the pumproom, discovered a leak coming from the forward bulkhead between the pumproom and the 5 Center (5C) cargo tank. The leak was located on the starboard side, upper portion of the bulkhead, in between two horizontal plates that formed the overhead of the pumproom. This small space was created in the shipyard, as a result of modifications to the pumproom overhead, in an effort to correct problems in the saddle tanks (ballast) directly above the pumproom.

19. The third mate informed the chief mate, who assessed the situation and in turn, informed the master. The chief mate testified that cargo was leaking at a rate of about "a gallon every five minutes, maybe less. It was a leak to be concerned about." Temporary repairs were proposed, loading 5C halted, and the cargo in 5C was gravitated into the 5 wing cargo tanks (5P & 5S), until the level was below the leak. The chief mate had rigged a ladder in the pumproom to gain access to the area where cargo was leaking, so that a temporary, epoxy patch could be applied. The chief mate slipped while descending the ladder and cut his finger, requiring stitches. He was sent ashore at approximately 0400. Meanwhile, the master notified the chief engineer and the first assistant engineer about the leak, and the first assistant engineer applied an epoxy patch and strongback as a temporary repair. The chief mate returned to the vessel about 0700 and was informed by the first engineer to delay loading 5C long enough to allow time for the patch to set up. Later that afternoon, loading in 5C continued and the repair in the pumproom was checked to determine if it was holding. The leak was still dripping, but was significantly less than before the repair.

20. Sometime that afternoon, a second leak was discovered in the same bulkhead, in a similar location as the first, but on the port side of the pumproom. The rate of this leak was "just a drip" and the master was so notified.

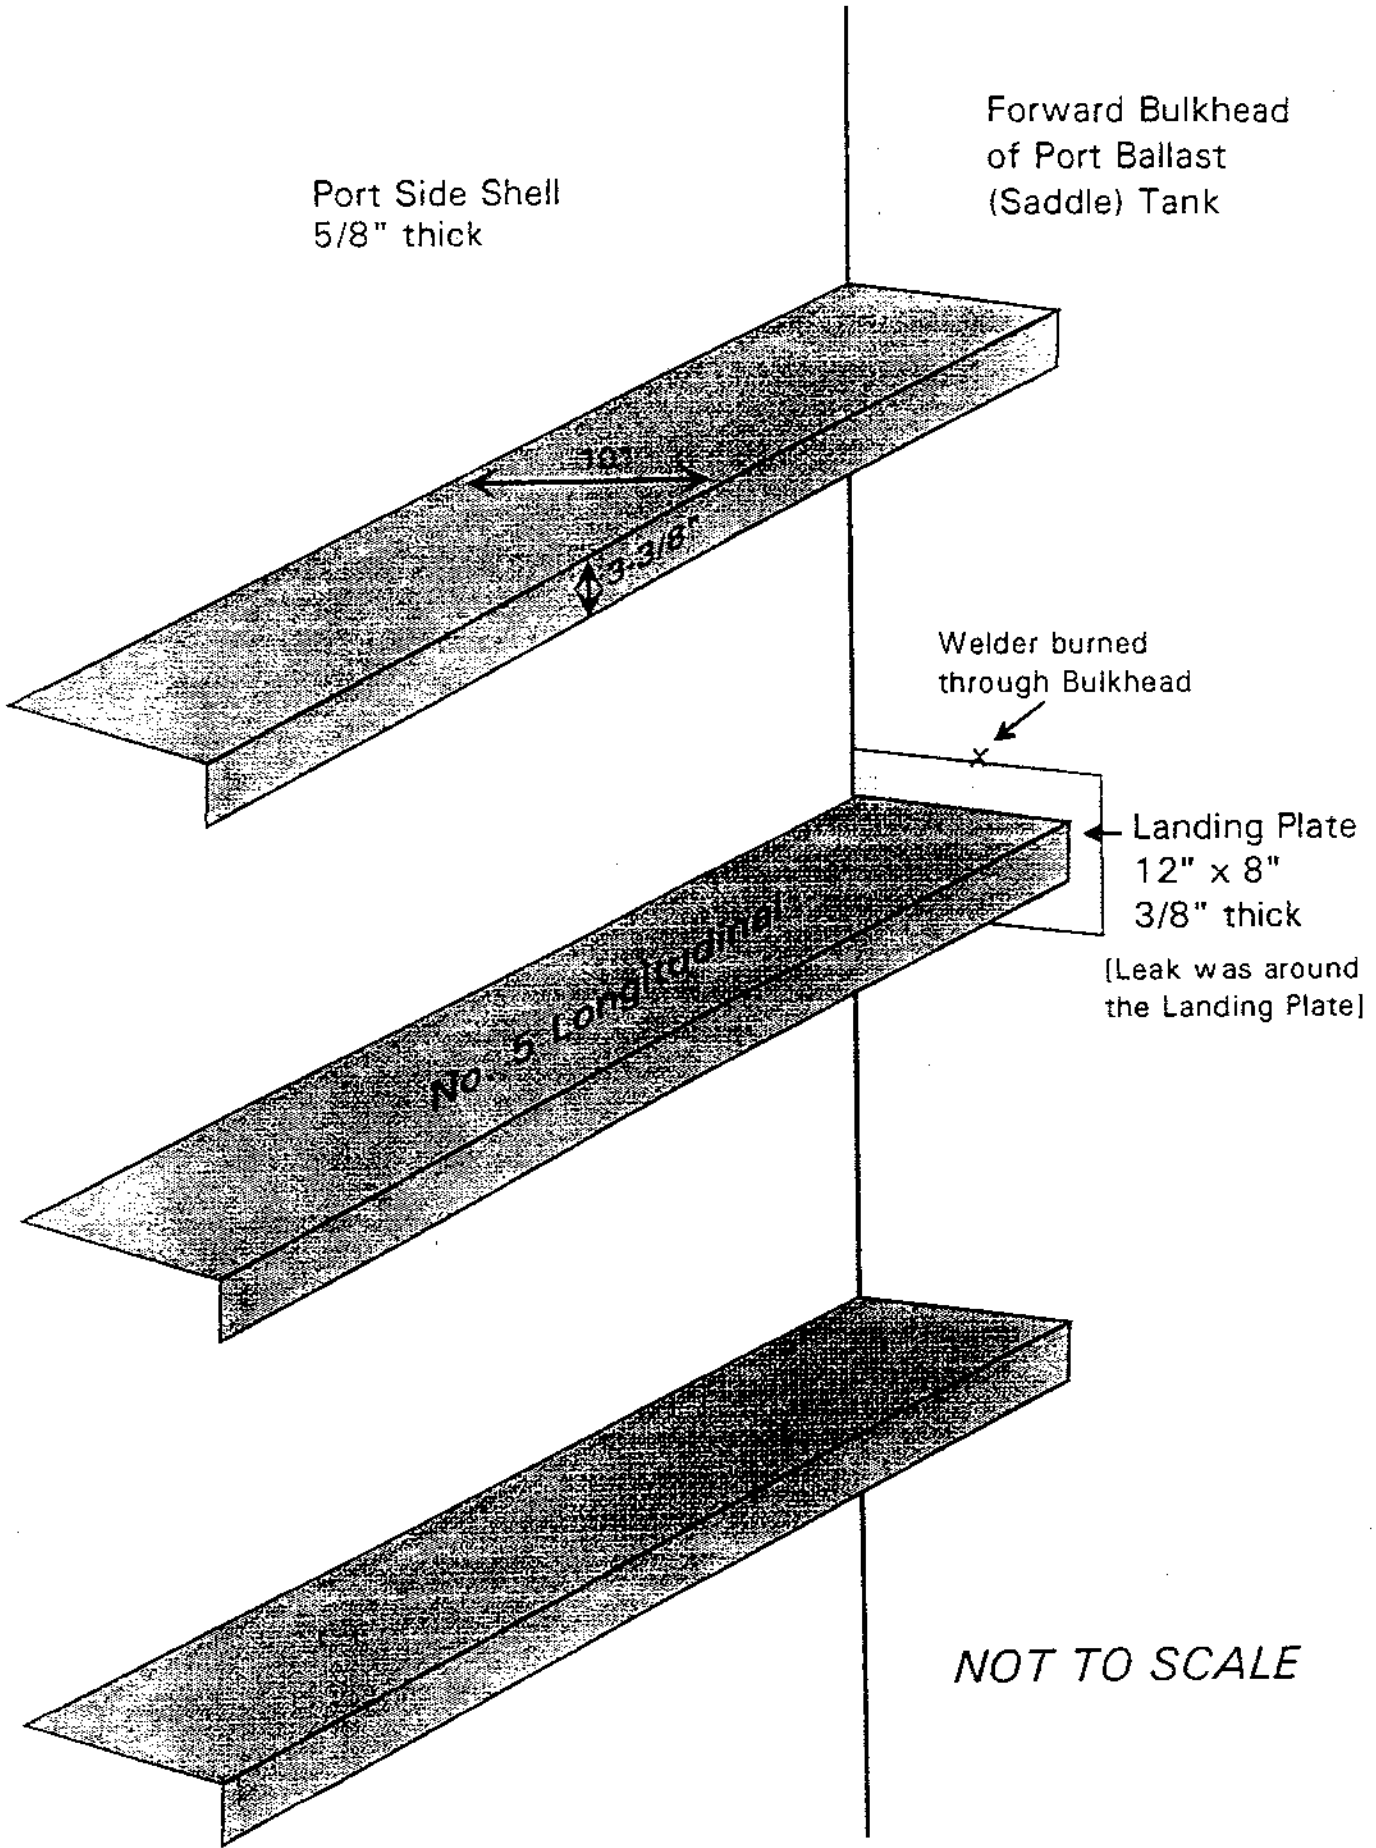
Figure 3, Location of Leak #3

24. At about 0800 October 2, the chief mate talked with the C. M. foreman, then entered the port saddle tank to further investigate the complaints. Using a gas detection meter he tested various locations in the tank without indication until reaching the outboard side of the tank, at the bottom, where the meter detected a rise in the percent lower explosive limit (%LEL). At this point the mate knew there was a problem, but still did not see any visual indication. Upon further investigation he noted a "weep" on the bulkhead adjacent to No. 5 port cargo tank, in an area around a 8 inch by 12 inch "landing plate," abutting one of the upper sideshell longitudinal stiffeners, which had recently been repaired in the shipyard. The chief mate informed the master, notified the C. M. gang to take their equipment out of the tank, and had a blower put over the manhole to ventilate the space. Meanwhile, the master called Mr. Blaustein on the cellular phone to discuss the latest development with respect to the leak discovered in the No. 5 port cargo tank "weeping" into the port saddle tank. Mr. Blaustein proposed to meet the ship in Tampa, because there was nothing they could do until the vessel discharged cargo. The morning of October 3, the chief mate checked the "weep" in the port saddle tank and determined it was not worsening, but the dampness had increased to about 3 feet below the weld, where the source seemed to be. No standing gasoline was found. Ventilation of the space continued with a copus blower over the manhole in the steward's storage locker and the butterworth opening on deck, port side, open.

27. The "weep" in the saddle tank (leak #3) was also thought to be a bad weld from the shipyard, and the proposal was to simply reweld it.

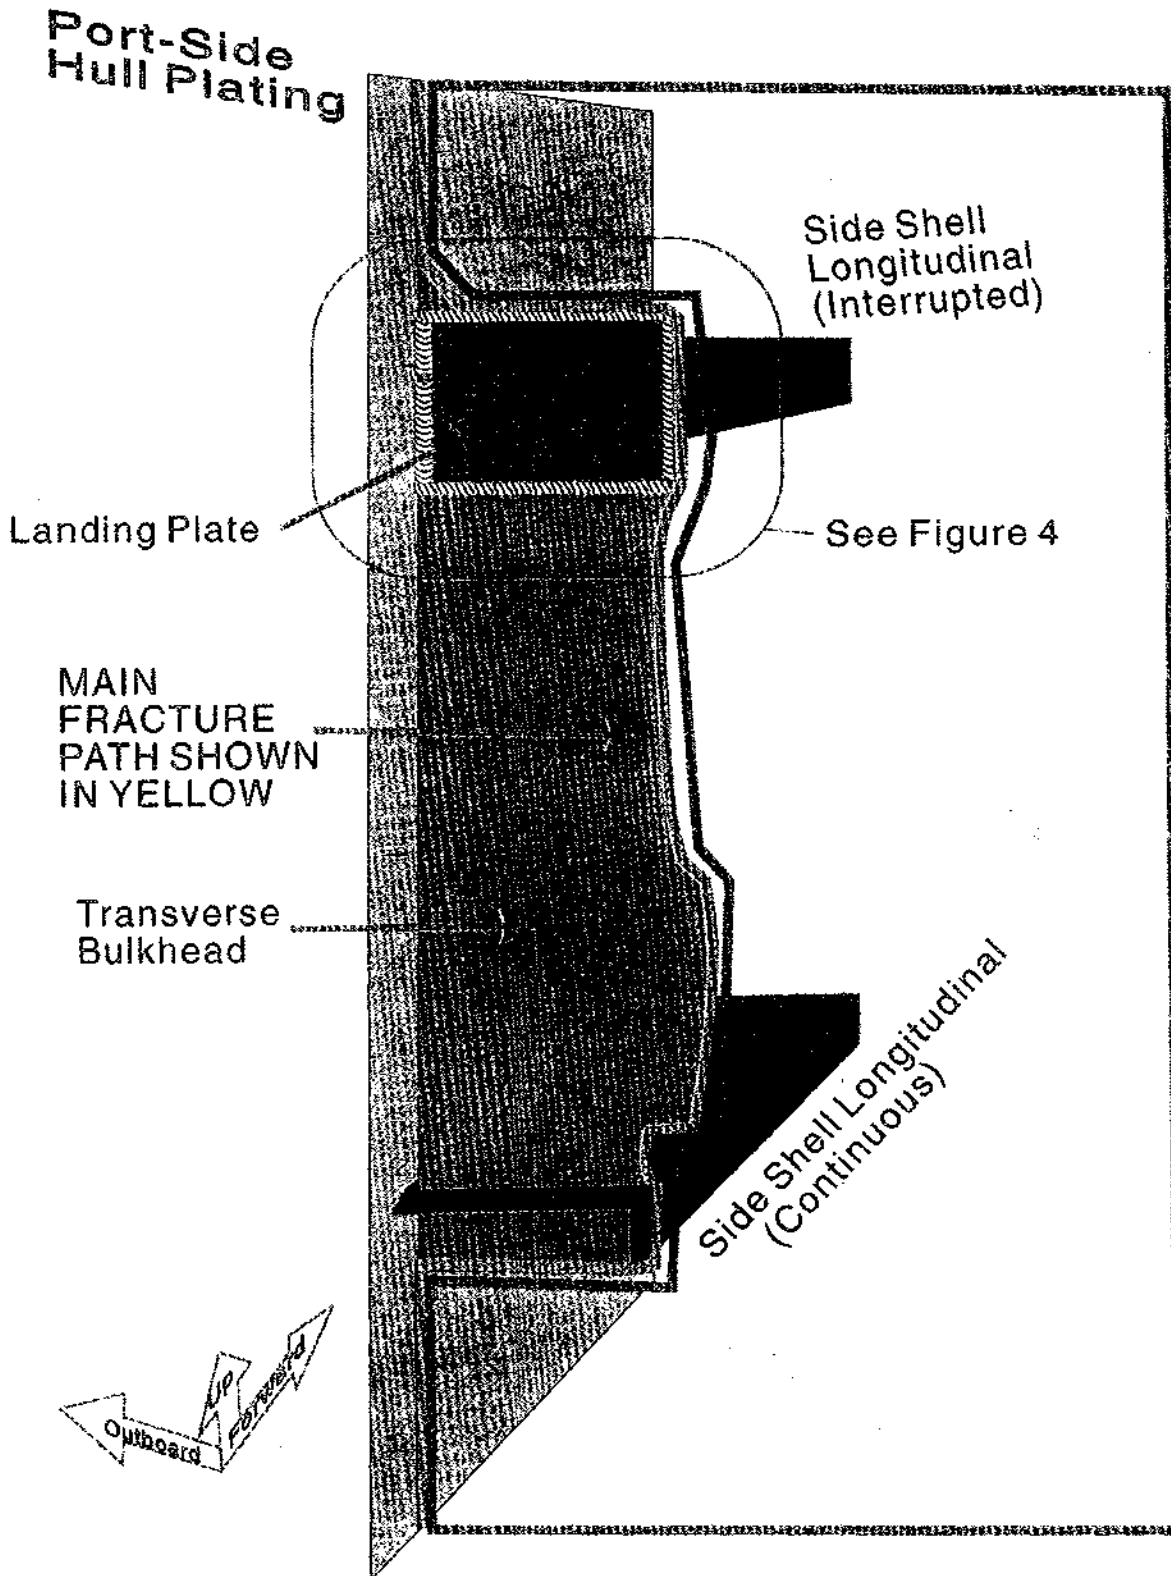
Figure 3 A drawing illustrating the arrangement of components. The main fracture path through the transverse bulkhead is denoted by the yellow line. The larger inboard piece of the bulkhead is shown as an outline for clarity. View is not to scale and shown without deformation.

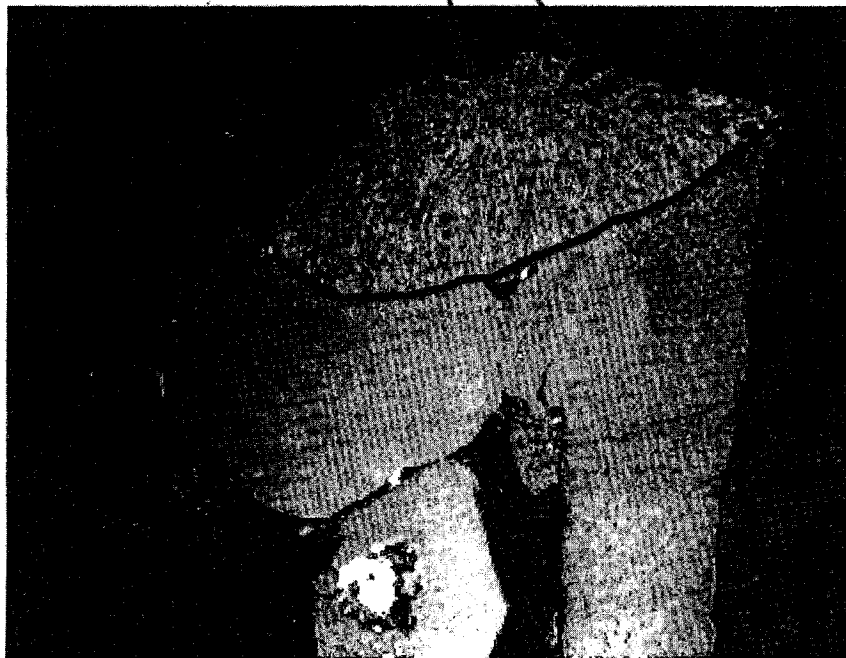
Figure 9 A 4X macrograph of a section through the top landing plate weld near the thin region showing the fissuring in the last weld bead. Also note that the fusion zone of the last weld bead, defined by the blue line penetrated through to the forward face of the bulkhead.
